November 5, 2018

EXECUTIVE SUMMARY

Walnut Creek Existing Park Buildings Assessment

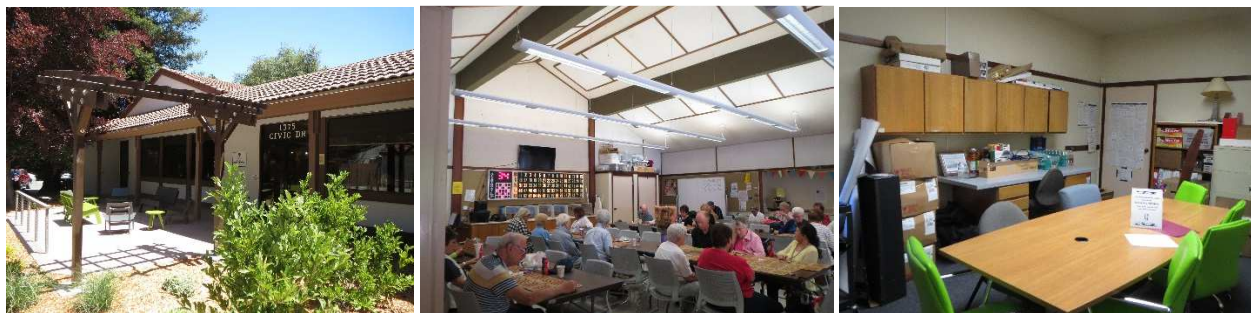
Civic Park Community Center

- Built in 1973, comprised of 8,325 gross square feet. This building has not had significant update to any of its systems, and only minor updates to solve some (not all) ADA issues. Finishes throughout are weathered and dated.

- There has been evidence of moisture infiltration into the in-slab duct system, in the form of perceptible mold odor during colder, wetter months. Repairs to this kind of duct system are often expensive because of restricted access.

- Renovation or addition to this structure is challenging because it has a slab-on-grade foundation over a high water table. An expansion of more than 50% of its footprint would require that the floor level be raised to avoid large flood events.

- The public restrooms were remodeled in the 2000s to accommodate ADA requirements, and a recent upgrade at the exterior makes the approach ramp accessible. Some building features still require modification to comply with ADA (entry door, e.g.).

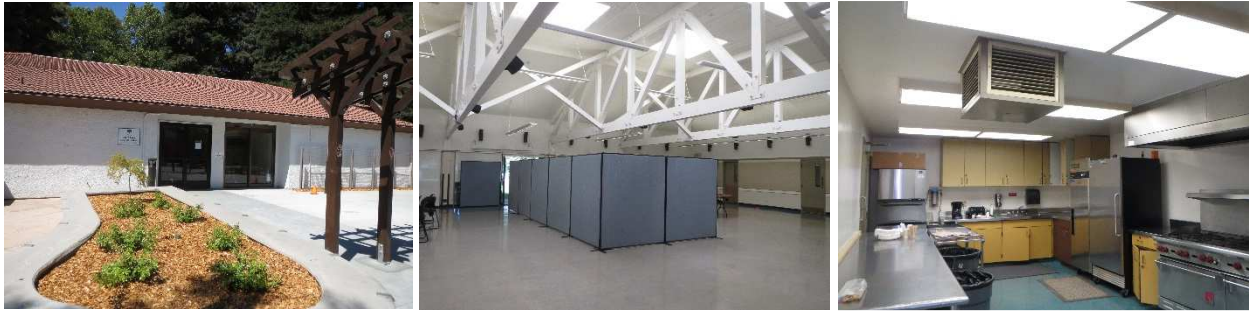
Civic Park Assembly Hall

- Also built in 1973, comprised of 5,400 gsf. This building has also not had significant updates to its building systems.

- Exhibits the same issues as in the Civic Park Community Center as far as slab-on-grade foundation and high water table, with restrictions to renovation and addition.
- The space is sometimes used for rentals, but has limited audio-visual capacity, and the weathered, dated finishes limit interest. The acoustical properties of the room make adding equipment challenging.
- The size of the main room is problematic for Arts & Recreation use: most events do not require such a large space, and staff have a hard time dividing the large room adequately to make useable spaces, nor have enough storage for the equipment needed for classes.

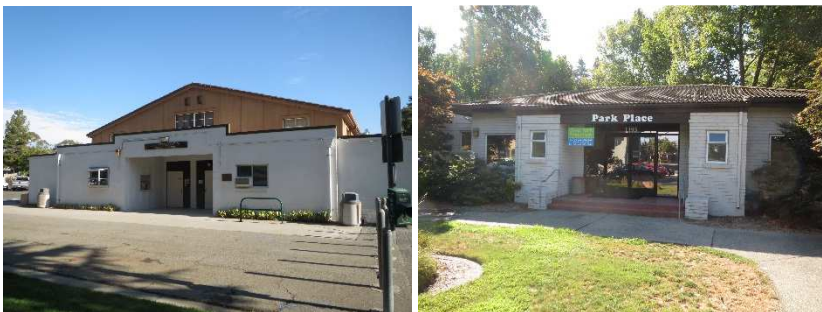
Clay Arts and Park Place

- These buildings were not directly observed, except at their exterior. They have been increasingly considered to be part of this Master Plan. Both were built in the 1950s, of CMU construction, and are located in Civic Park. Park Place is comprised of 1,700 gsf and Clay Arts has 3,300 gsf.
- Neither building has had significant updates to their system; both are weathered and, considering the age of each building, are functional, though not ideal, for the programs they house.

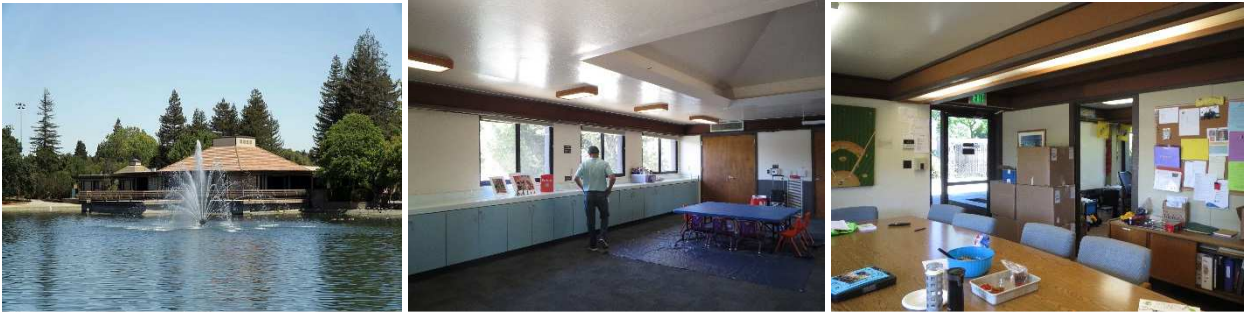
Heather Farm Park Community Center

- Built in 1972, comprised of 8,900 gsf. There has been partial replacement of the HVAC system. The unreplaced portion is also an in-slab duct system with reported mold issues. Some, not all, ADA issues have been addressed.
- There are reported to be structural beams in the roof system that show evidence of decay. There is visible sagging at the roof eave lines. Because of the building's proximity to water, it seems likely that there may be long-term vapor and/or biological damage to the structure which should be investigated.

- The larger of the two rooms available for public use, the Lakeside Room, is a popular rental because of its views of the adjacent pond. Both rooms are difficult to use for Arts & Recreation programs, due to the large size, difficulty dividing them adequately to make useable spaces, and do not have enough storage for the equipment for classes.
- There are no other rooms, no useable lobby space, no gathering spaces for the community, such that there tend to be very few community members present aside for specific events. The people who are most often present are the staff who work in the administrative offices housed here.

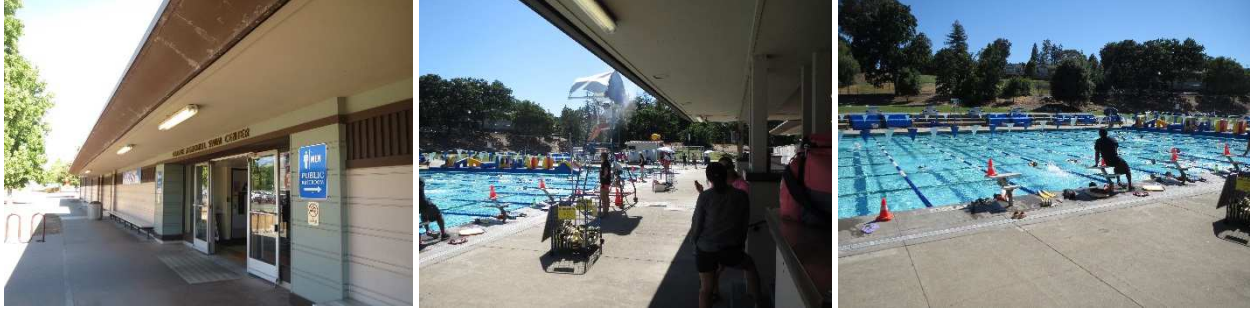
Clarke Memorial Swim Center

- Built in 1967, comprised of 7,010 gsf of total building space, and three pools. This building complex is also located in Heather Farm Park. There have been no significant upgrades to the building systems or pool infrastructure, only minor modifications to adapt to changing uses. Repairs to the pool system now require custom-made parts and specialized knowledge.

- A separate, formal analysis of both the Clarke and Larkey pool facilities was conducted in 2010 by a consultant specializing in aquatics facilities. Their conclusion at the time was that both pool facilities should be replaced; repairs and renovation would be too financially prohibitive. The Larkey pool and equipment was replaced, and the adjacent building renovated as a result of this analysis, and has seen a resulting, large increase in attendance.

- There is currently far more demand for pool use than can be accommodated by the Clarke facility. Lanes are constantly full, and different programs overlap in non-ideally shared use. Many of the smaller offices and classroom spaces are too small to accommodate the trainings and meetings that are held there.

- Renovation of a pool system as old as Clarke is not advised because of how difficult it is to access the systems for pool maintenance, especially the underground portions. Similarly, the pool house has been subject to nearly fifty years of water and chemical exposure, and is likely too damaged to be worth salvage. Finishes show significant wear.

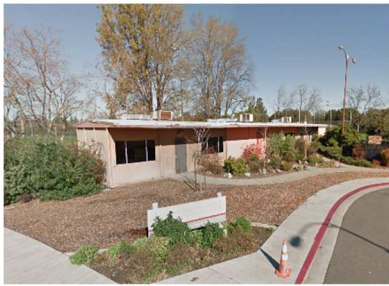
Studio H

- Similar to Clay Arts and Park Place, this temporary building in Heather Farm Park is increasingly being considered as part of this Master Planning effort, although it was not directly observed. It is comprised of 3,020 gsf. It pre-dates the 1980s, and was meant to be a temporary facility.
- Because this building was intended to be a temporary facility, it is degrading more rapidly than the other buildings, and is therefore limited for meaningful future use.

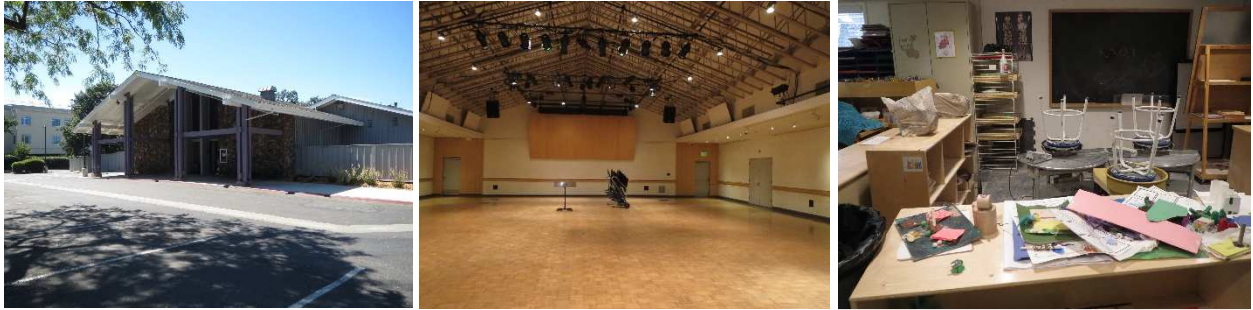
Shadelands Art Center Main Building

- Built in 1975 comprised of 16,180 gsf. Renovations occurred in the late 1990s, when the city came into possession of the property, and again in the 2000s to amend for program functions and ADA accessibility. The HVAC system has been recently replaced.

- The auditorium in this building is the most technologically advanced amongst the park buildings assembly spaces, and is heavily rented. The adjacent warming kitchen has not been updated, which is limiting for patrons.

- The renovations made in the 1990s and 2000s did not solve all of the functional issues in program spaces. There is bad acoustical separation, poor finish durability, very little storage, and a need for specialty spaces for the unique equipment required by the different arts classes that are housed here. If arts programs from other parks are moved to this location, additional space will be required, as it is currently at capacity.

- While the building systems are in the best repair of the six buildings under consideration here, this building suffers the most from lack of clear circulation. It is quite difficult to discern where the entrance is, or how to navigate to any of its classrooms.

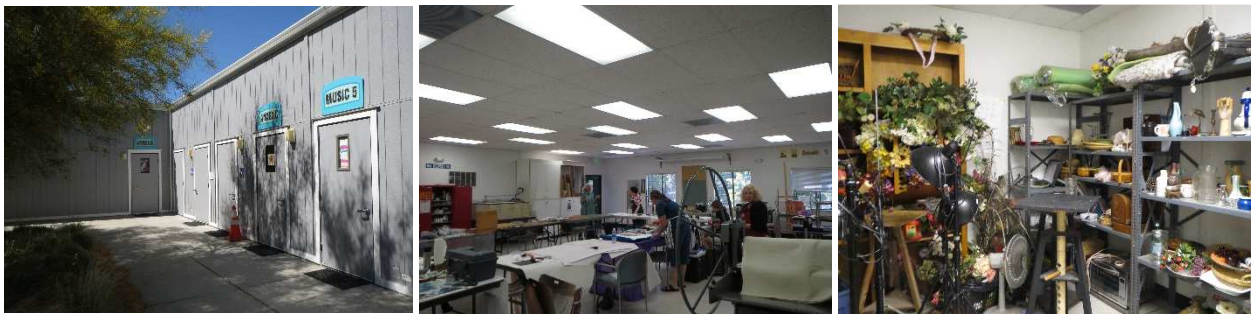
Shadelands Art Center Annex

- Built in the early 2000s, comprised of 4,020 gsf. This building consists of two attached, semi-portable, prefabricated structures, meant to last for 20 years. The building is therefore nearing the end of its warranted use, which in the case of temporary structures, is more critical, and significant damage is likely to appear.
- There is inadequate storage for the materials for the diverse art classes held here, and underutilized spaces dedicated to old uses (e.g. photo lab).
- There is more demand for art classes than can be accommodated here.
